**River Loddon Woody Debris Site Visit**

Tuesday 26 August 2008

**Visit aims and objectives**

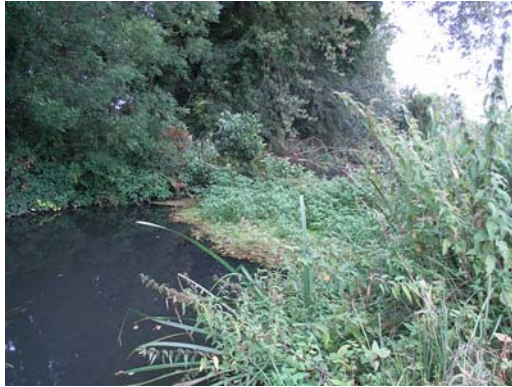
1) The Loddon is impounded upstream of Longbridge Mill for a distance of over one kilometre. This means restricted river flow and energy to erode and deposit and therefore create new habitat. There are many similar impoundments in the Loddon catchment. WD will have limited effect on creating diverse habitat in impounded catchments. WD will, however, provide

valuable overhead and submerged cover for fish and wildlife as can be seen in photo 1 on the next page.

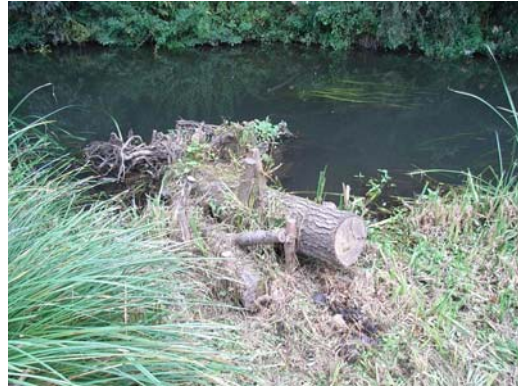
2) Photo 2 shows where WD has been trimmed and staked to the bank. In this example, WD was likely to drift off and could have caused blockages downstream at the Mill. It was also inhibiting casting and this warranted management intervention. In this scenario in impounded water, the WD provides good winter refuge for fish, a range of invertebrate habitats within root systems and silt retention on the inside and downstream of the feature.

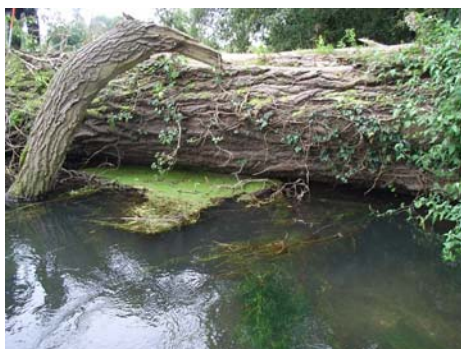
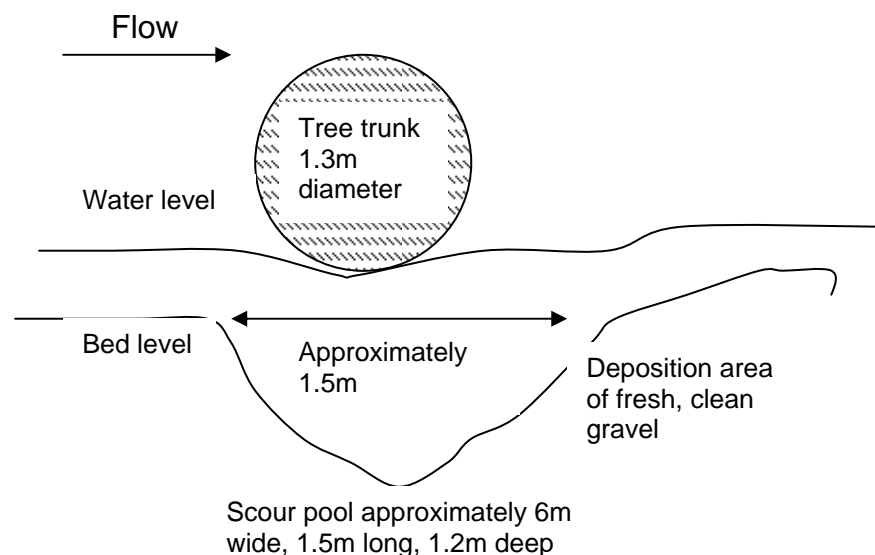
3) and 3 schematic diagram)

3) This huge tree trunk (diameter approximately 1.3m) in photo 3 below had fallen straight across the river at the same level as fairly normal summer flow. The trunk has been in position for approximately two years. In increasing winter flow and rising water levels, water is forced underneath the trunk scouring an area almost proportional to the trunk size. See diagram below.

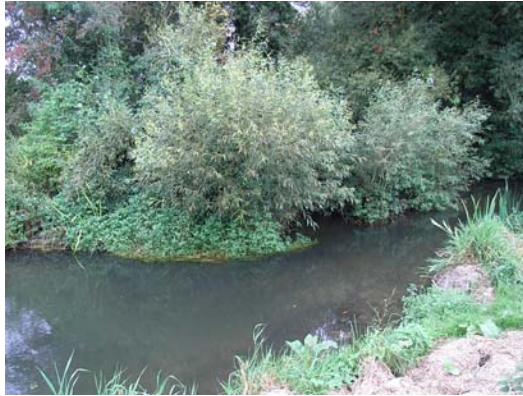
4) below

4) Photo 4 over page demonstrates a good example of managing WD for creating a valuable trout lie. In this case, there will be limited geomorphological benefit as the Loddon at this point is still impounded by the

weir and the WD is not of sufficient size to cause increasing flows to the extent that the bed is scoured and coarse substrate moved downstream.

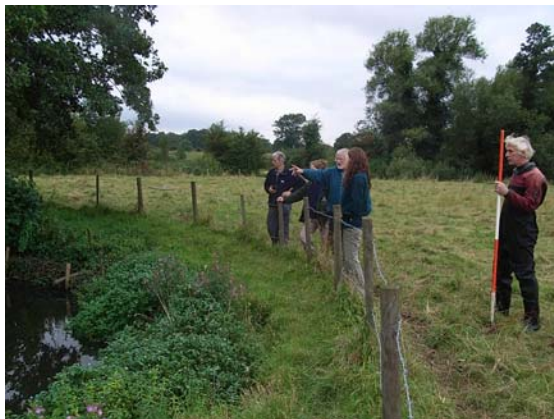
5a)

5) Photos 5a to 5d show a classic example of the use of local fallen willow branches to protect banks from erosion. 5a shows our group inspecting quick regrowth of sprouting willows and diverse emergent vegetation including purple loose-strife (*Lythum* sp.) (5b) growing amongst water mint (*Mentha* sp.), water forget me not (*Myosotis* sp.) and others. We noted that this micro colony of aquatic plants would not last long unless growing willows were regularly managed to avoid them shading out these emergents.

long unless growing willows were regularly managed to avoid them shading out these emergents.

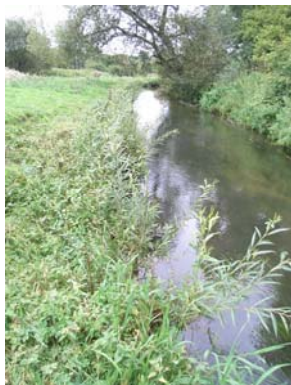
5c)

Photo 5c shows the length of bank protected facing upstream and 5d faces downstream with the flow towards the protected bank.

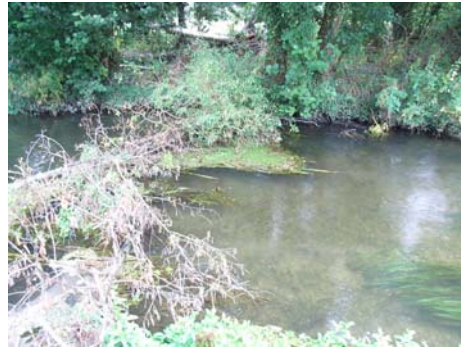
6) A moderately sized fallen bough extends across the Loddon providing good cover for younger wild trout and diverse flow patterns. A weed raft has formed around branches in the centre of the channel providing the refuge in addition to the trailing branches extending from the trunk.

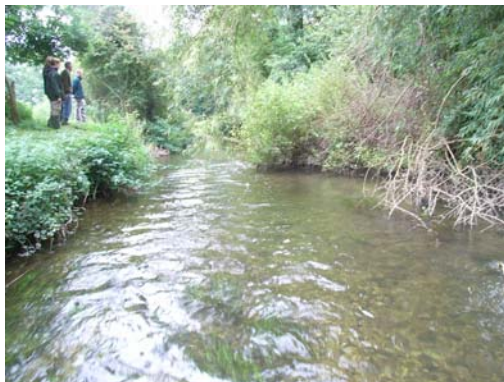
7a)

7) 7a Below shows the group observing a WD flow deflector upstream of where the impounding effect of the weir stops. Willow branches and small bough extend almost halfway across the channel pinching and concentrating flows causing broken water, local scour and silt deposition. Managing WD in this way has saved the Society over £100 in materials and faggots (or similar) if a similar flow deflector were to be installed.

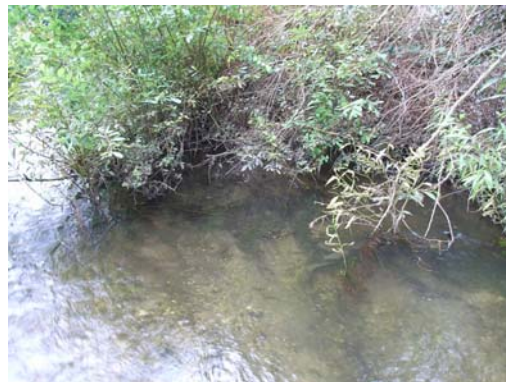
7b)

7b shows the site of silt deposition. In time (possibly two to five years), this area will continue to silt up narrowing the channel and improving the efficiency of the deflector to scour and deposit clean spawning gravels for native brown trout downstream.

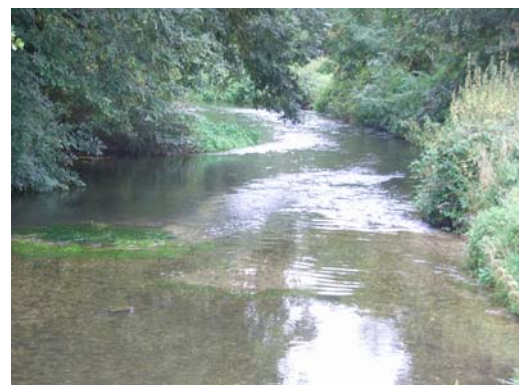
8 right) We come across the first growth of water crowfoot (*Ranunculus* sp.) over one kilometre upstream of Longbridge weir. This is downstream of a former weir structure on a sharp left hand bend. Gravels eroded in the weirpool are deposited at the tail providing a clean well aerated substrate with broken water giving conditions suitable for growth. Water

crowfoot indicates good chalk stream health. In this section of the Loddon it is rare. This means more work is required in promoting the conditions for it to grow and WD is one of the management techniques that can be used.

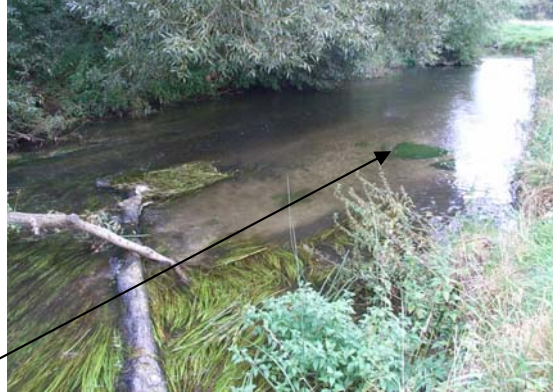
9) see arrow for location of water crowfoot growth.

9) Water crowfoot growing in similar conditions on the tail of a shallow pool. This time it is probably there because WD is concentrating flow, scouring and depositing clean gravels downstream on which this aquatic plant is growing (see arrow).

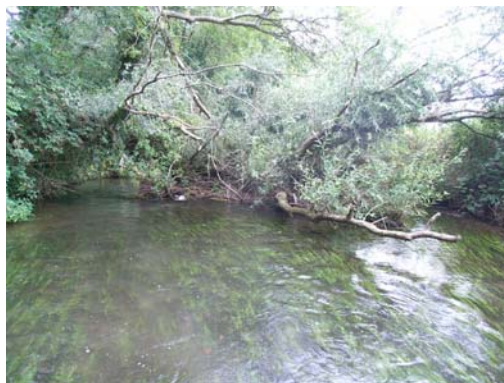
10a)

10) LWD creating some of the best conditions for wild trout spawning (photo 10c,d) in the River Loddon upstream of Longbridge Mill. Photo 10a looking downstream shows the size of large WD in relation to channel width. The channel is approximately twelve meters wide. Large WD covers approximately 60% (six to seven meters) of the channel width. This forces water mostly around the left hand side of the object creating a dramatic vertical scour pool (10b), depositing fresh, clean gravel downstream (10c).

It must be mentioned, that flood risk is low in this rural area. These trees will be monitored for erosion and mobility and will be removed before the event of problems to the weir structures at Longbridge Mill over 1.4km downstream. The effect on local flooding will be limited as banks are high at this point and once water rises over the top of the object no notable difference should occur. There was no observed difference in up and downstream water levels at the time of visit.

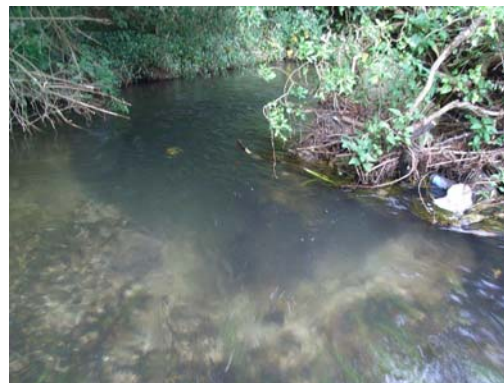
10b)

It has taken two years for this LWD to scour and move approximately six cubic meters or more of clean gravels. The processes involved are similar to those in the schematic diagram shown in on page 2. Water depth upstream of the LWD is about 0.3m to 0.4m. As water reaches the LWD, depth plunges almost vertically to 1.3m to 1.5m over a distance of 0.2m or so (10c). Coarse gravels are deposited 2m to 3m downstream of the object forming a riffle with broken water less than 0.1m deep.

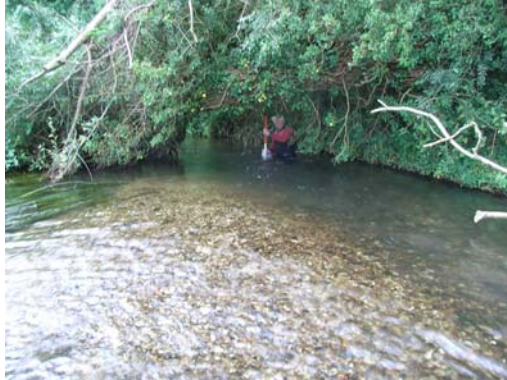
10c)

Large WD can significantly improve wild trout hatching success (and other gravel spawning fish) in rivers where silted, accreted gravels are a problem.

This is because the difference with gravels downstream of this feature is that the gravel is loose and water is flowing up and through the gravels thereby creating excellent hatching conditions similar to upwelling systems in trout hatcheries. We will be monitoring spawning at this site amongst others.

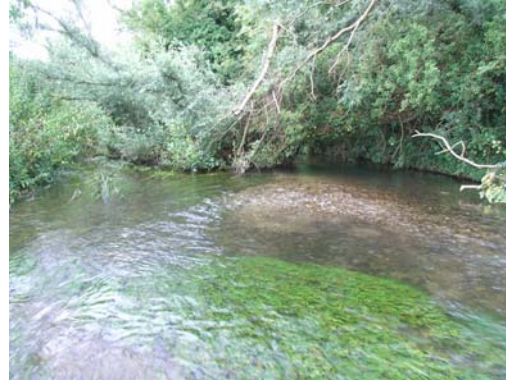
10d)

Photo 10d looking back upstream to the LWD, shows the complex mosaic of flows, macrophytes and habitats downstream. LWD tidy for nature and saving the Society upwards of £500 for creating a new wild trout spawning ground.

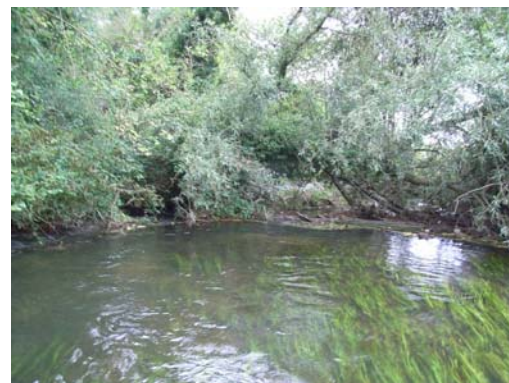
11) Debris dam. Of WD viewed this example was the only one where any difference was observed in up and downstream water levels (approximately 15cm difference). LWD and collected drifting boughs block much of the channel forcing water to back up, flowing over and under the collection of branches (11b). This back up effect extends possibly to the next bend 30m or so upstream.

This complex type of habitat in chalk rivers is extremely rare. Significant habitat and flow diversity occur over a small area. This LWD creates spawning and nursery habitat for fish, deposit areas for silt, coarse and fine particulate organic matter vital for many invertebrate species. It will be very interesting to monitor morphological changes around this LWD in time. 11a)
