LODDON FISHERIES AND CONSERVATION CONSULTATIVE

PENNYWORT POST – Spring 2025

An update on the ongoing Yateley Pennywort situation,
with reports on the rest of the Loddon catchment

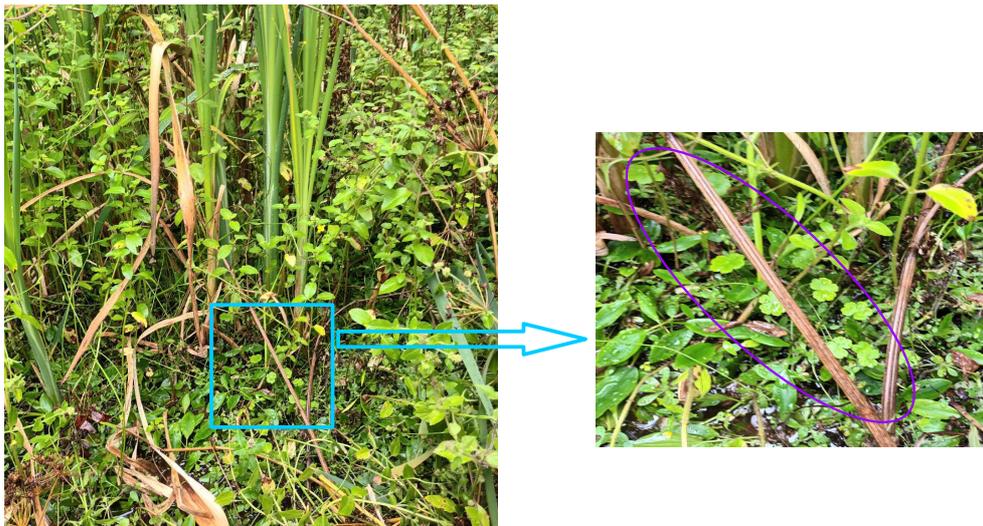
Wyndhams Pool. As noted earlier this year, the spring check is made easier by less growth of the other plants. 7 pennywort plants were found but they were well hidden below the growth of reeds, iris and mint. Care was taken to remove the rhizomes but regrettably two of the smaller plants did break off so there is potential for regrowth from these fragments. As previously the plants were all found in a relatively small area. Despite frustration that we are still finding these plants, it is encouraging that we are even managing to detect them in a challenging situation, and will hopefully be reducing the potential for re-growth

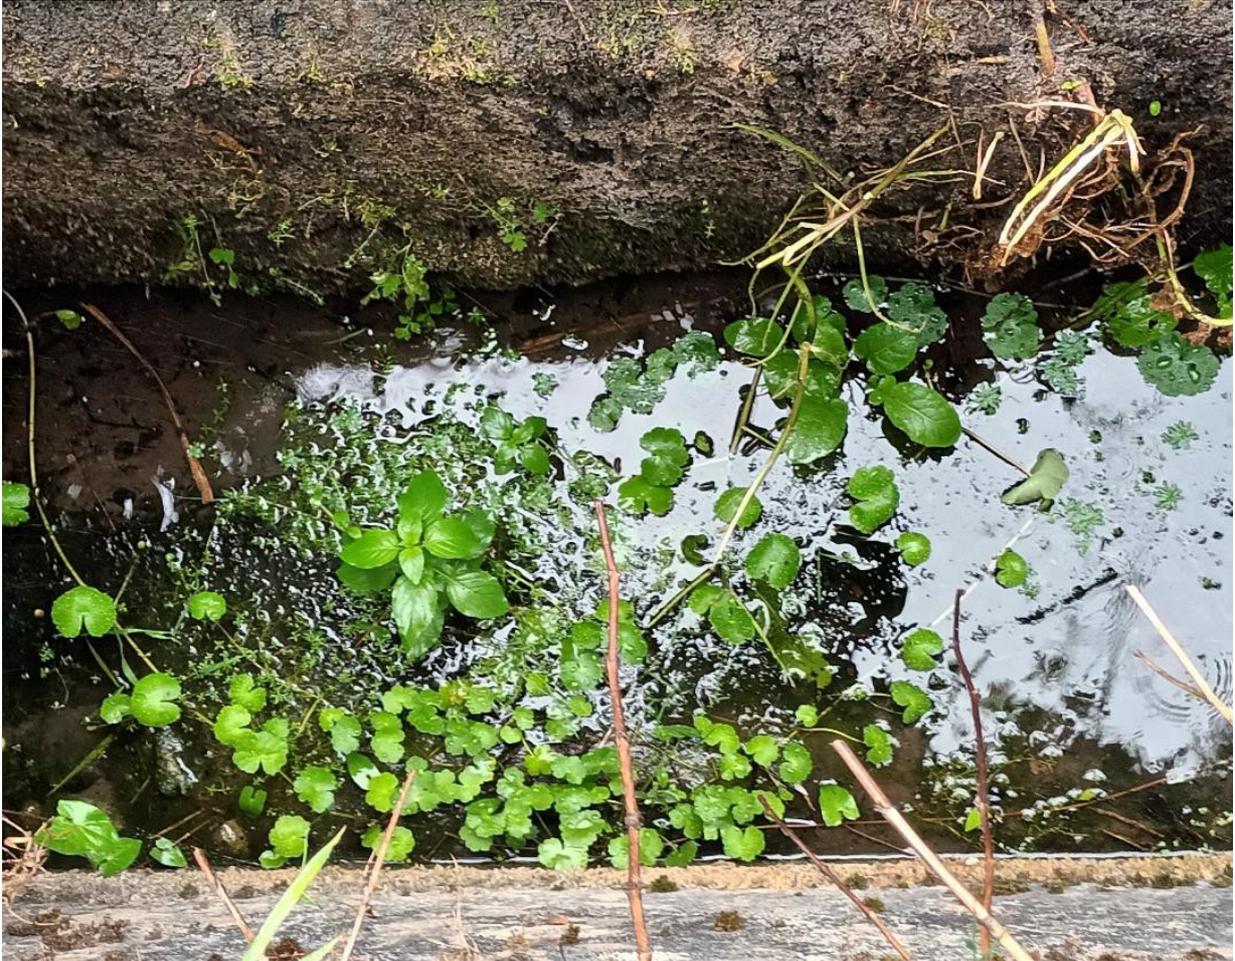
A full check along the towpath between Gelvert Stream overflow and the Fox and Hounds Public House was conducted. 9 small but viable fragments were removed from the towpath bank, and it was felt likely that more fragments would have been present along the opposite bank. An inspection by boat would have increased efficiency. Most of the fragments had a reasonably thick rhizome, but their size was much smaller than expected, none were longer than 20cm. One significant plant was found at the Gelvert overflow in the concrete channel immediately below the overflow. This displayed the type of growth that a small fragment would have been expected to achieve since the last inspection.

The Basingstoke Canal Authority are continuing to lead efforts on the canal and their ranger patrols are looking out for pennywort.

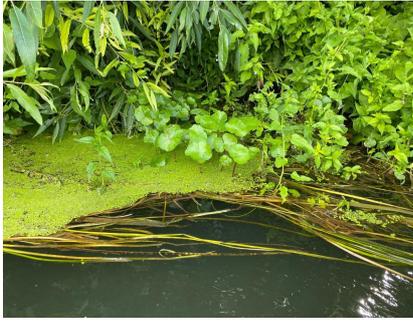
The third boat based visit in early August was very encouraging apart from the final few metres. Less than 10 plants / fragments were found, either caught up in debris accumulating on branches, or growing in shallow muddy bays. This was significant improvement to the visit earlier in the year. It probably reflects the fact there were no large rafts upstream releasing fragments.

Fragments accumulating on branches

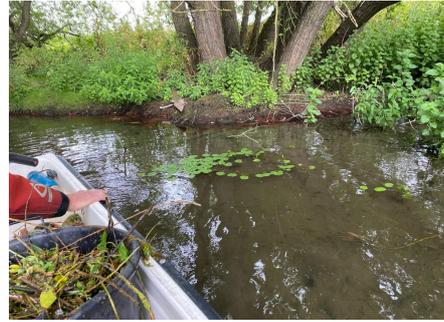
Growth in shallow bay

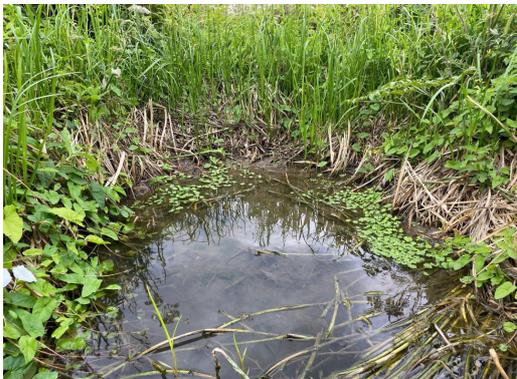
One of the small slots described above did produce more plants. The spraying had eliminated the cover concealing these plants although it was difficult to determine if the lack of cover was simply making detection easier or if it had reduced competition from other plants, thus facilitating the pennywort growth. The leaves of these plants were very small, yet the rhizome hidden in the mud was fairly thick and plainly storing enough potential for producing further growth. The extraction of these rhizomes was difficult owing to the clay underlying the mud.

Growth in 'slot'

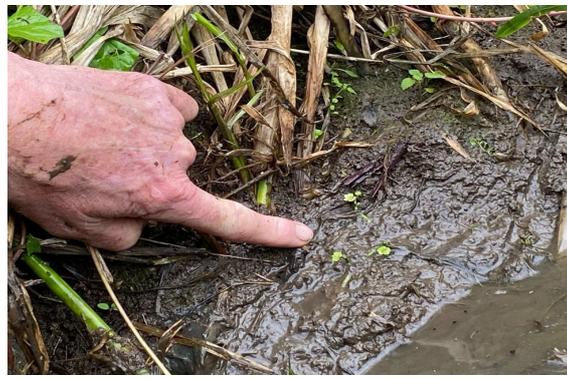
Size of some leaves

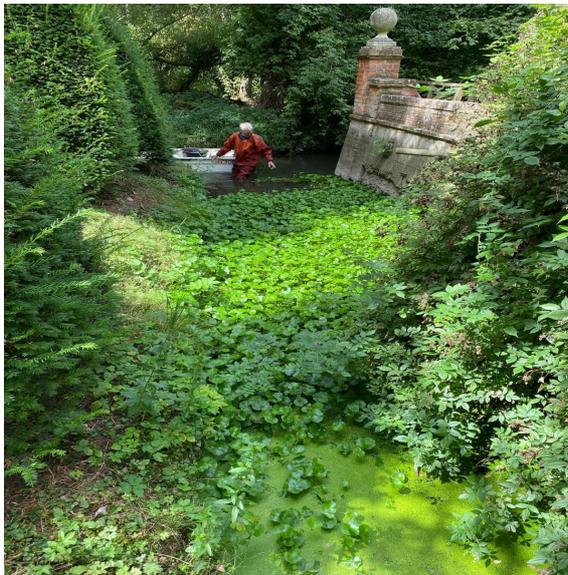
The slots will require further attention, as will the final channel inspected. This was a short 50 metre long side arm off a small channel itself running off the main stream. As can be seen from the photo there has been a very significant growth of Floating pennywort in this part of the system. It is almost certainly the result of this having no flow, with just a single opening to the rest of the system, whilst there is little competition from other plants. Despite it being a significant area of growth of a large established nature, good access and the shallow depth should make removal relatively easy. This will be the target of a further visit.
