LODDON FISHERIES AND CONSERVATION CONSULTATIVE

PENNYWORT POST – Autumn 2025

An update on the ongoing Yateley Pennywort situation,
with reports on the rest of the Loddon catchment

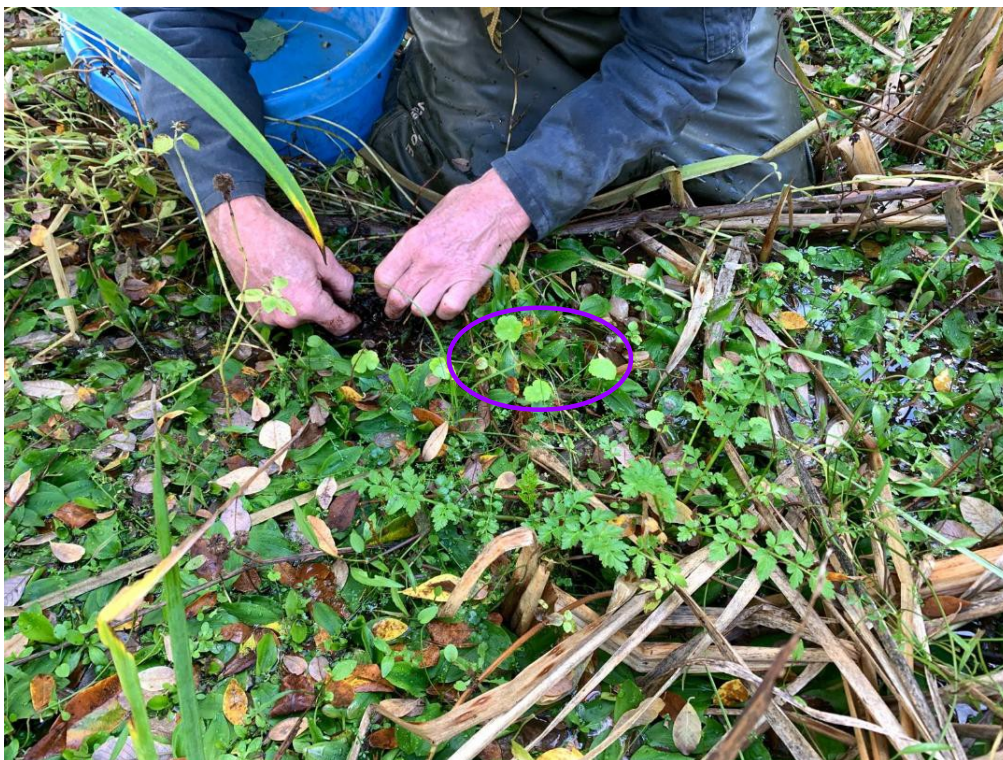
Wyndhams Pool. The 'hotspot' at Wyndhams Pool has again produced some plants. It is noticeable that the leaves were actually bigger and more easily detected on this occasion, probably due to the favourable growing conditions experienced this summer. This facilitated removal, in that the sub-surface rhizome was thicker and easier to follow. However a couple of breakages did occur so it is suspected that there will be further re-growth to deal with during the next visit. As can be seen in the photograph the leaves were more obvious than on some of our visits

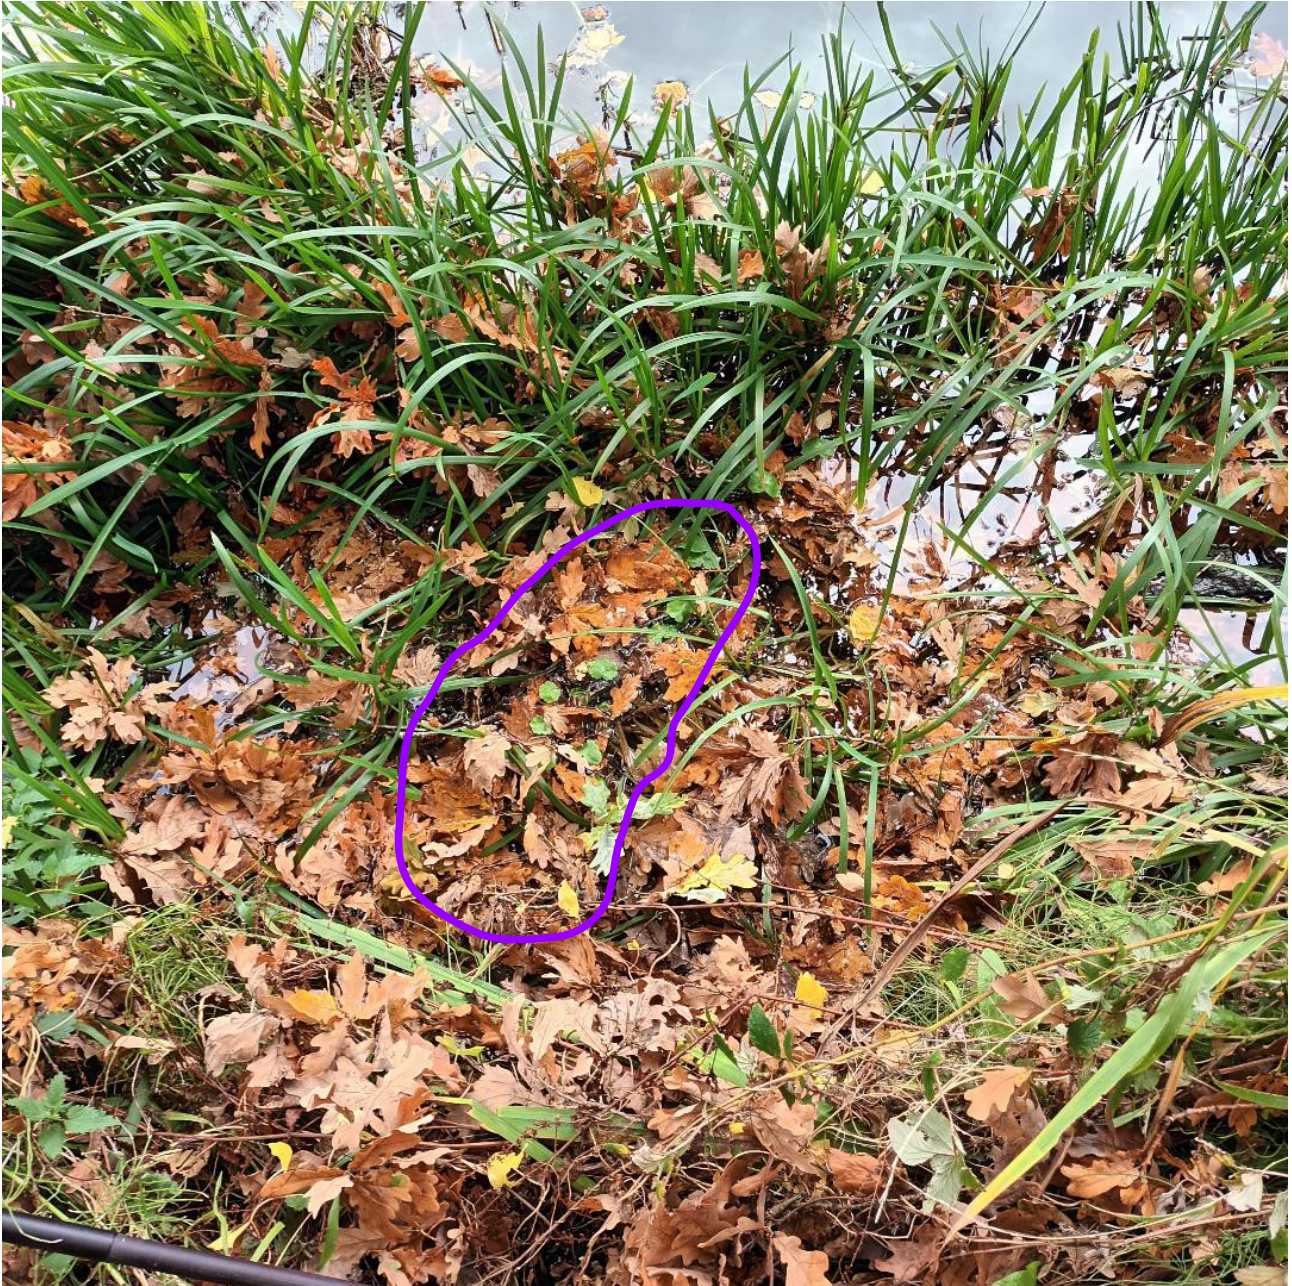
Basingstoke Canal – Fleet.

A full check along the towpath between the Gelvert Stream overspill and the Fox and Hounds Public House was again conducted. As with the last visit, 9 fragments were found, and despite the significant leaf fall, that had accumulated in some areas, there was confidence that the towpath bank had been surveyed thoroughly. All but one of these plants were free floating but one was found to be rooted and growing in a bed of *Glyceria* (see below). More fragments would almost certainly have been present along the opposite bank. An inspection by boat would have certainly increased efficiency.

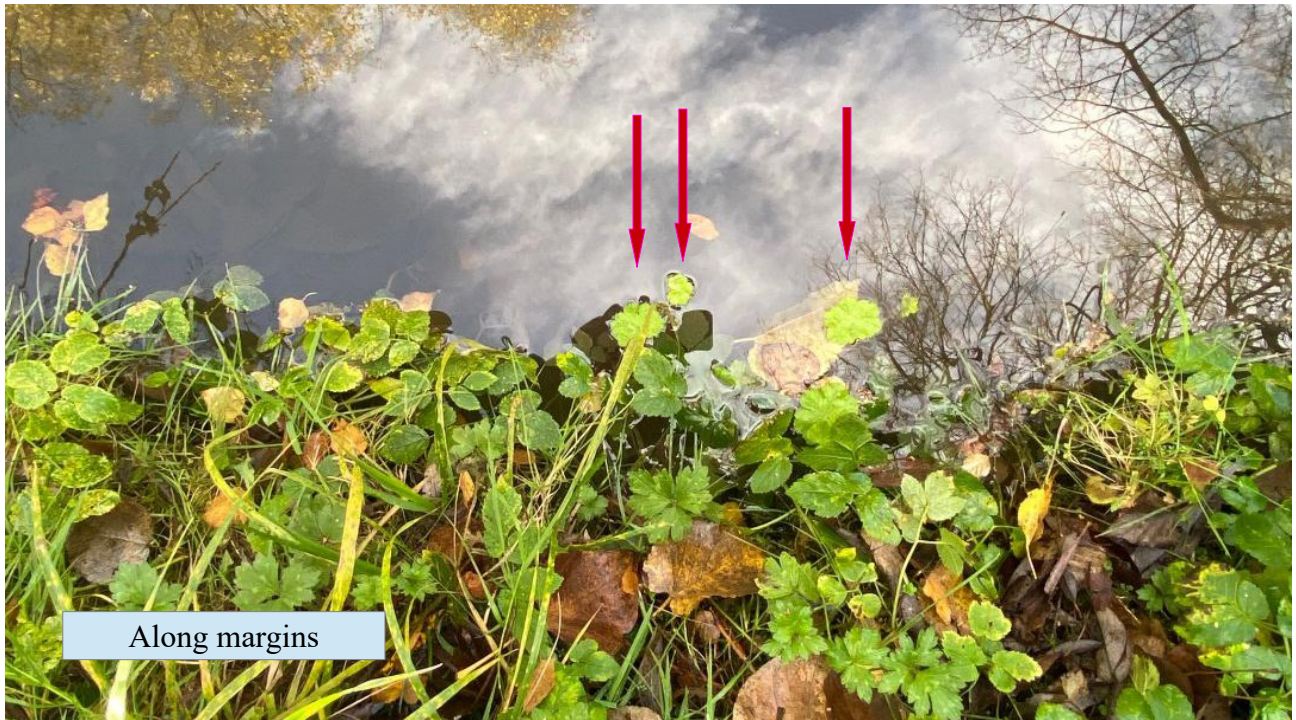
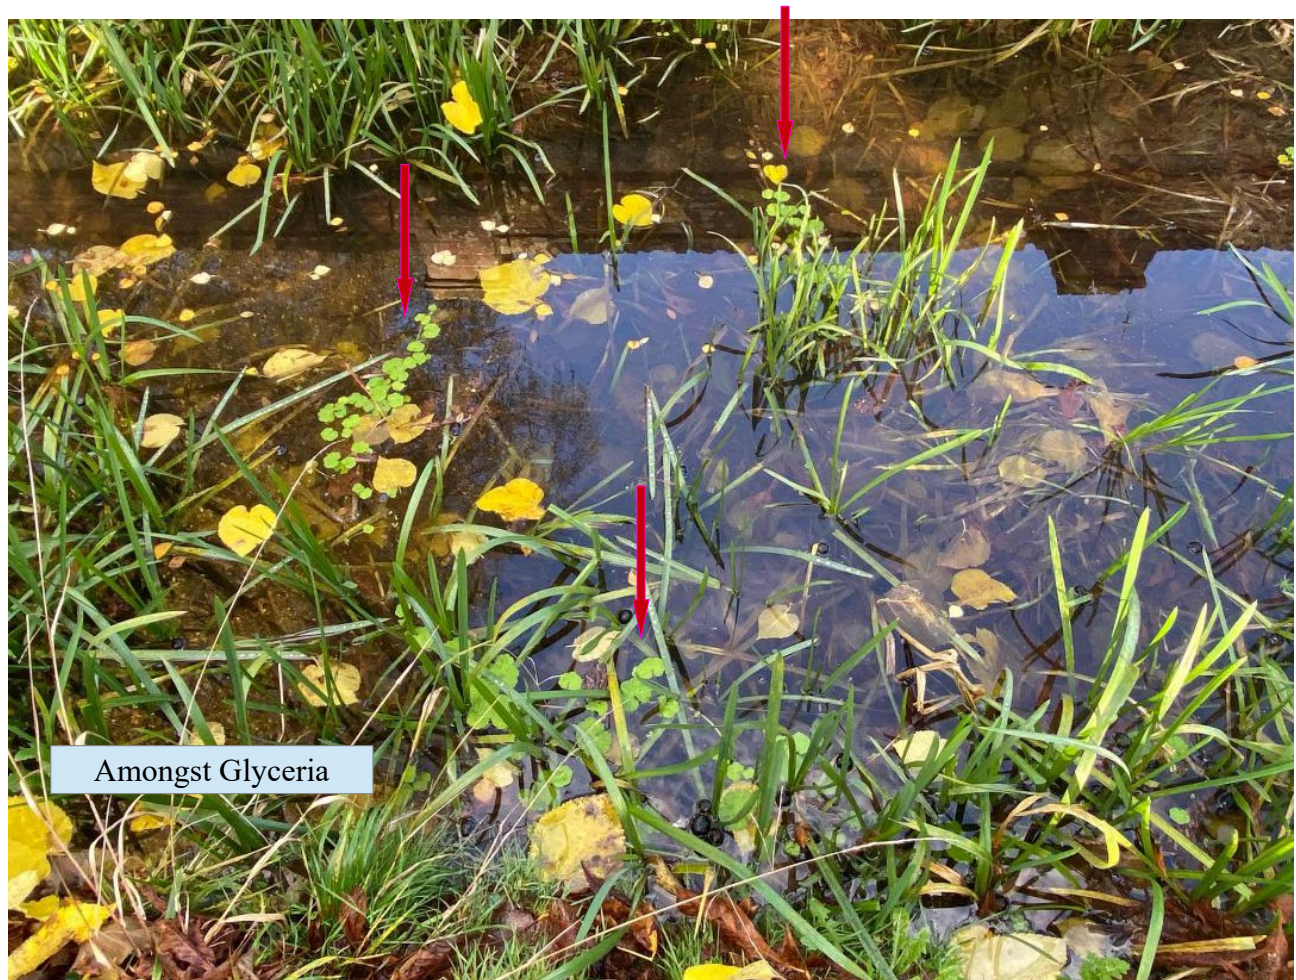
Charvil.

A further visit to the Borough Marsh Stream site at Charvil was carried out in mid November, and this will require a follow up. The work conducted this year has significantly reduced the presence of the pennywort, but there are some persistent plants well rooted in the clay banks, with some mopping up in the moat section required, whilst a significant patch found at the rear of a reed bed.

The moat section was cleared, although some regrowth is expected next year. However the autumn die back of other plants has increased the efficiency of this removal. A follow up visit in the near future will address the newly found patch in the reedbed and provide a further chance to tackle the few persistent plants in the 'slots' at the head of the channel.
