## River Nene: Castor Back Channel

Version 1 (24.11.12)

| <b>Location:</b> | Downstream of Water Newton Weir (c3km west of Peterborough) |

**Summary of Techniques:** Bank reprofiling; bank revetment using ash faggots and spiling; installation of ash faggot flow deflectors; securing in-stream woody debris; gravel introduction to augment an existing run; excavation of new fish refuges; installation of new cattle drinkers and a “dog-dip”; riverside fencing; willow pollarding; riverside tree planting to create shade; and wildflower seeding. The bridge beams were also repainted with vandal resistant paint to address an existing graffiti issue.

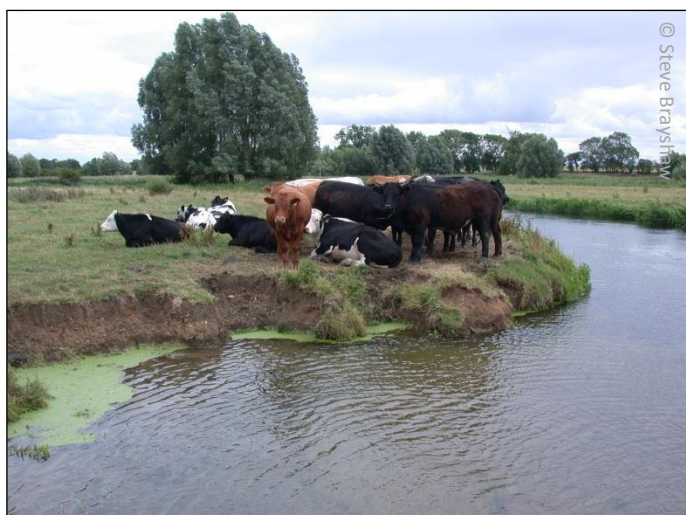
Fig 1. Severe erosion by cattle at drinking locations

The majority of the right bank and the upstream and downstream ends of the left bank suffered from very severe erosion, mainly from cattle, but also from people and dogs. The majority of the severely eroded banks were reprofiled behind ash spiling, backed with a geo-textile membrane, with faggots being used to consolidate the bank

### Cattle Drinkers

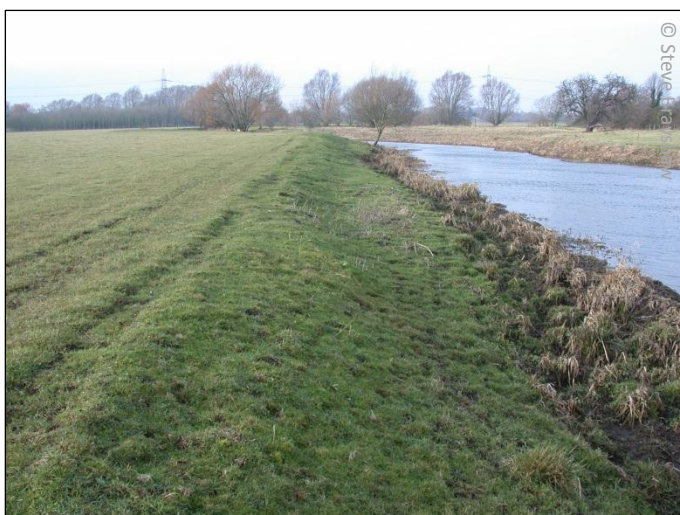
Fig 2. Wide channel with uniform flows during the winter, few shade trees on south bank, cattle poached margins

During the summer months extensive beds of in-stream vegetation (in particular grey club-rush *Schoenoplectus tabernaemontani*) created useful flow variation. However, in the winter, when the vegetation died back, flows were more uniform. Consequently, to create year round variations in flow, ash faggot and hurdle deflectors were installed. As well as increasing the flow velocity, the deflectors will encourage siltation at the margins of the channel and this will allow the extent of the marginal vegetation to increase, whilst maintaining an open, energetic central channel. All, apart from one, of the deflectors point upstream to reduce the potential for bank erosion. The downstream pointing deflector, located to protect and encourage the extension on an existing *Schoenoplectus* bed, deflects the flow towards a section of the bank that has been protected by spiling revetment. Note - initially a much larger number of flow deflectors were planned, however the number was reduced because the channel was too deep for them to be installed.

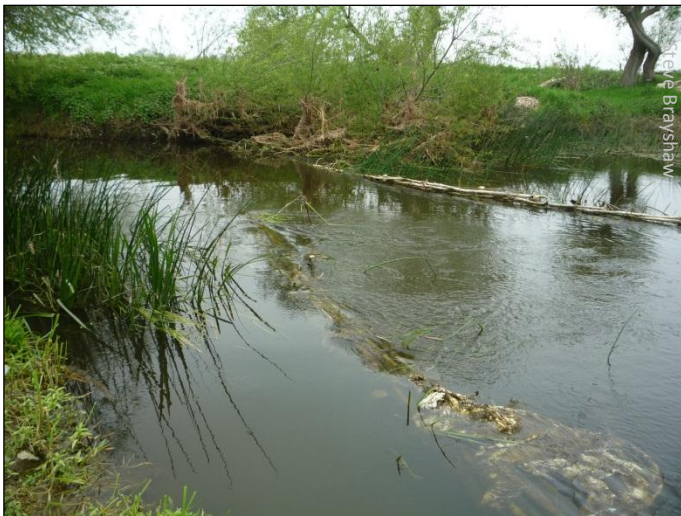
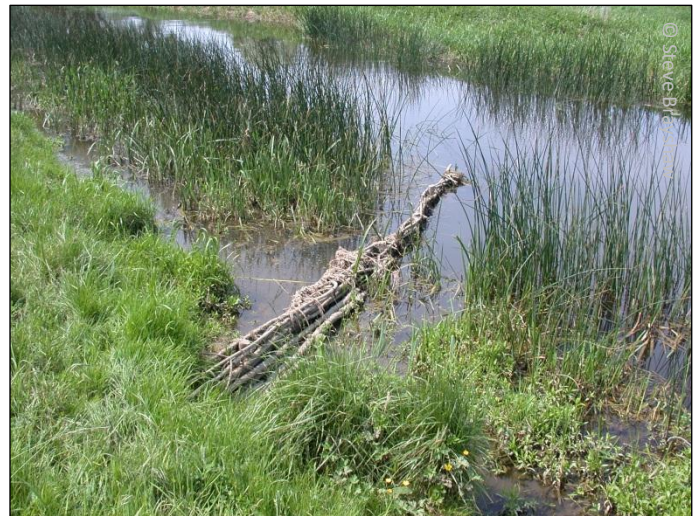
Figs 3 & 4. Faggot deflectors used to pinch the channel and to consolidate existing and encourage future siltation

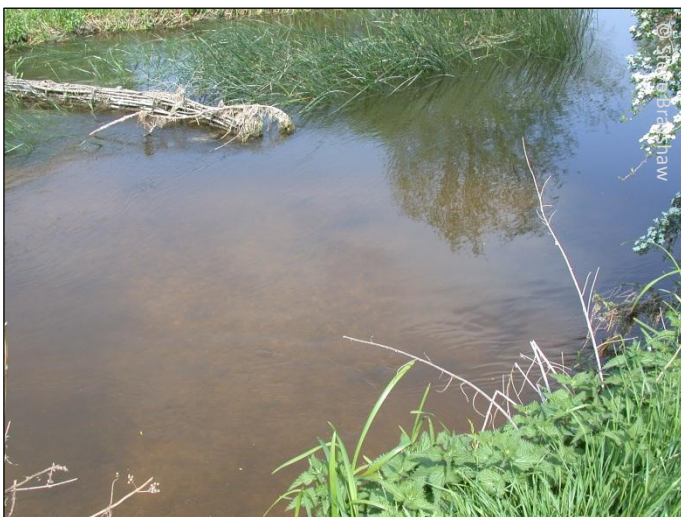
Fig 5. Gravel placed to augment an existing run

The bed gradient varies along the back channel, with steeper, faster-moving sections with relatively lightly silted gravels, interspersed with deeper, slower, siltier sections. A long section of gravel bed was located between the

sharp bends in the middle of the reach. The run was augmented by the addition of 40 tonnes of 20mm diameter gravel to improve opportunities for fish spawning and habitat for invertebrates. In addition, an ash faggot flow deflector was installed to concentrate the year round flow over/through the gravel to ensure that siltation was minimized. The gravels, which remained in place following the high spring flows, immediately attracted large chub and barbel.

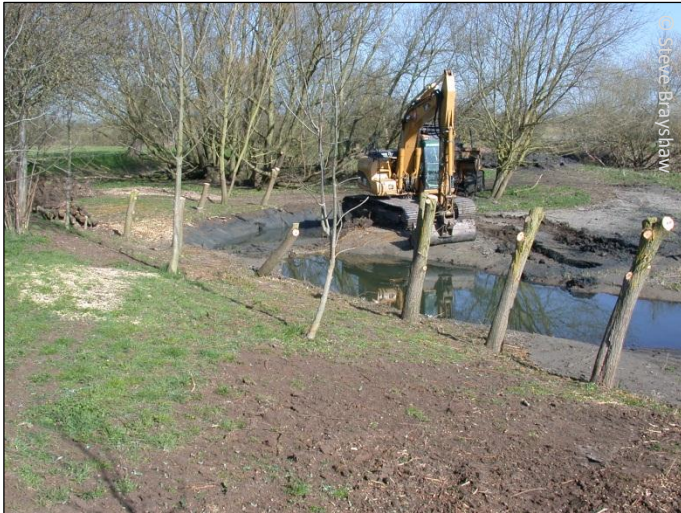
Fig 7. Lower refuge pool under construction

Two pools were excavated on the existing lower lying areas within the channel. These pools are designed to act as fish refuges during medium to high flows. The downstream pool is within an area of wet woodland and a line of new pollard willows on the southern side will provide additional shade.

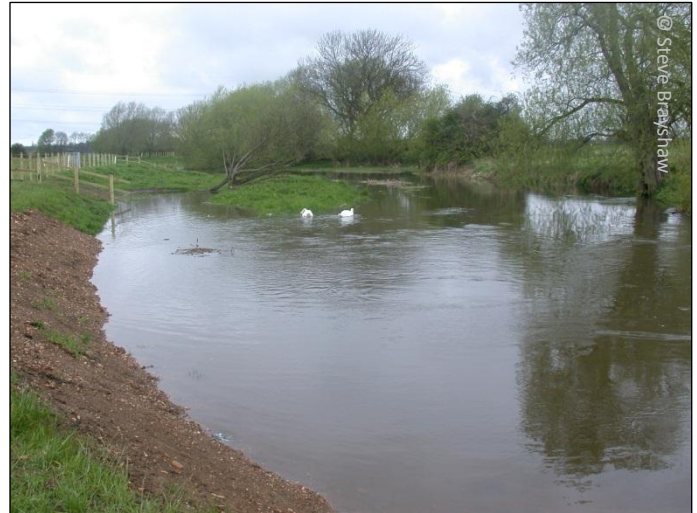
Fig 8. Upper refuge pool during high flows in April 2012

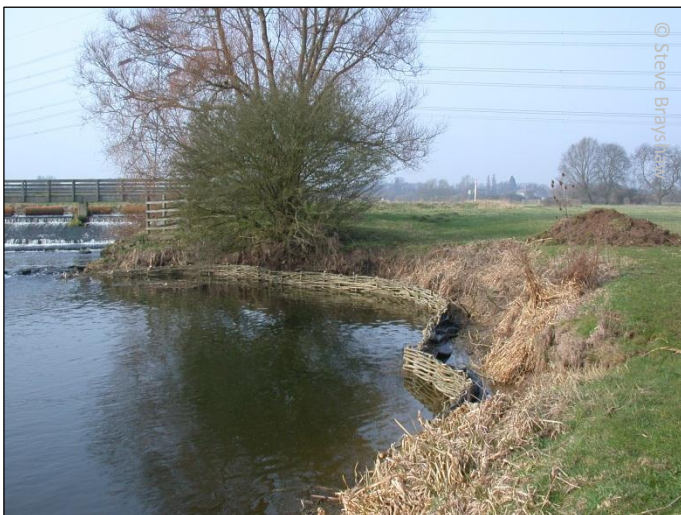
Fig 9. Ash spiling used to protect bank toe

toe where the bed was extremely hard. The bare earth on the reprofiled was seeded with a simple meadow grass seed mix augmented with the addition of some wild flower seed derived from the species list from Castor Flood Meadows SSSI just downstream of the back channel.

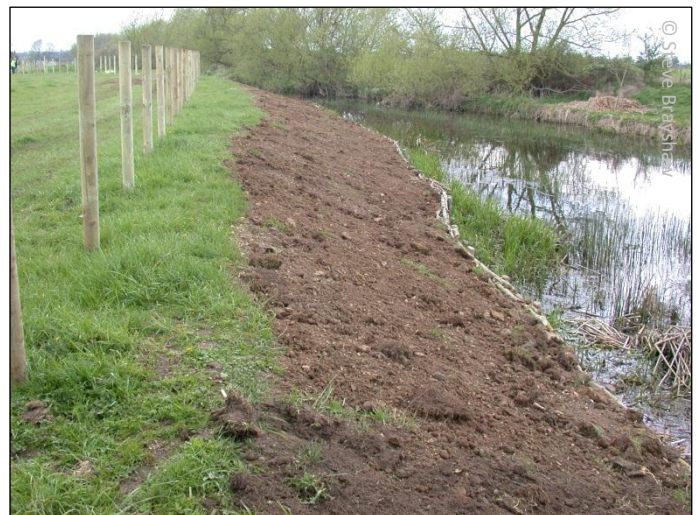
Fig 10. Eroded bank reprofiled behind spiling

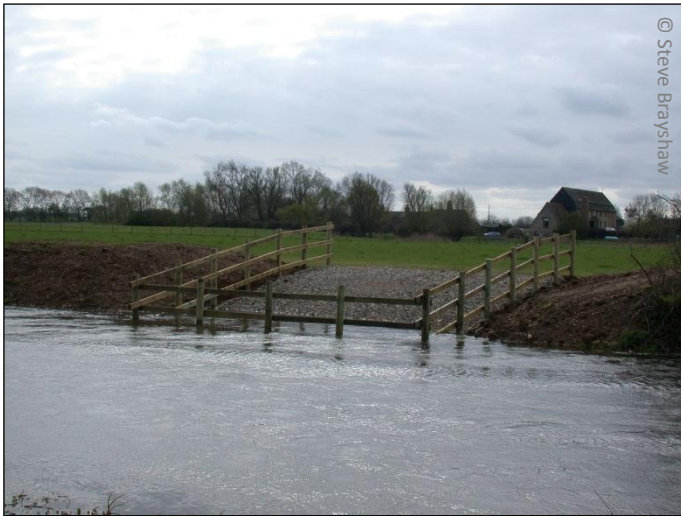
*Figs 11. New "standard" cattle drinker*

The river has traditionally been used to provide drinking water for livestock, but there was no specific provision of drinkers to limit the widespread impact of severe poaching. To reduce the impact cattle drinkers were installed at the (severely eroded) favoured drinking places in each of the fields. Excess earth, excavated during the construction of the drinkers, was used as supplementary fill behind the bank toe protection (see above). The cattle drinkers on the right bank comprised post and rail enclosures with a base of rammed limestone. However, because of the excessively hard bed adjacent to the left bank drinker the specification was modified to use angle-iron uprights instead of wooden posts on the front fencing to prevent stock from entering the river.

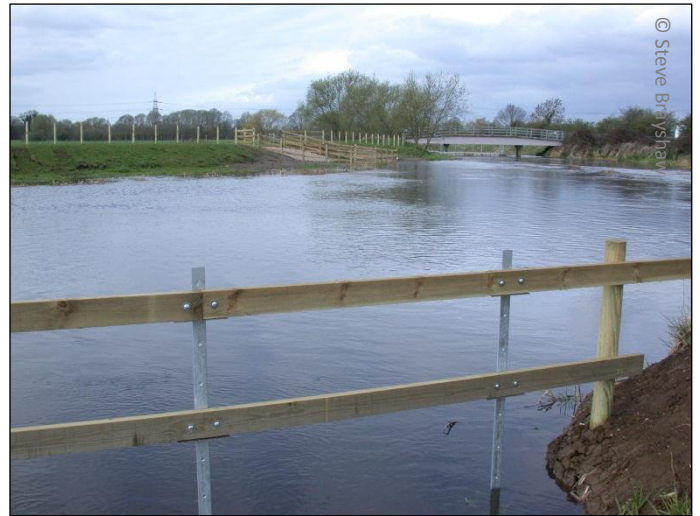
*Fig 12. Cattle drinker front fencing showing angle iron uprights used to penetrate the hard river bed.*

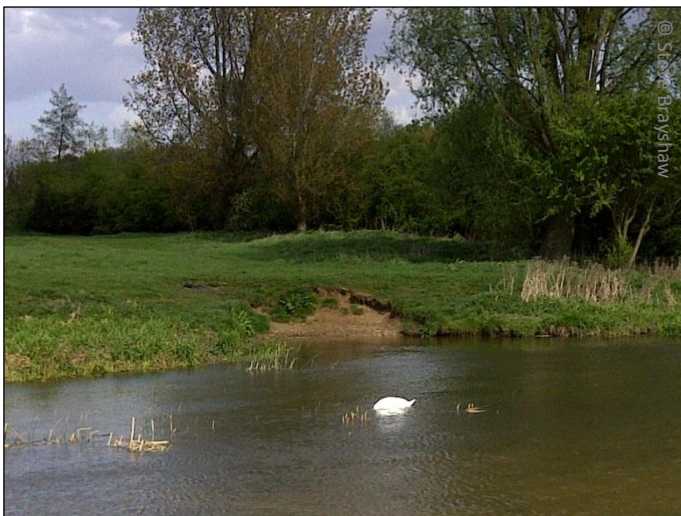
*Fig 13. Before: the eroded recreational access*

In addition to the cattle-eroded areas, there was a section of eroded bank caused by recreational access. Rather than prevent access to the water here the bank was reprofiled and the bank and river bed were dressed with gravel to allow the use by people and dogs to continue but to limit the impact of soil erosion.

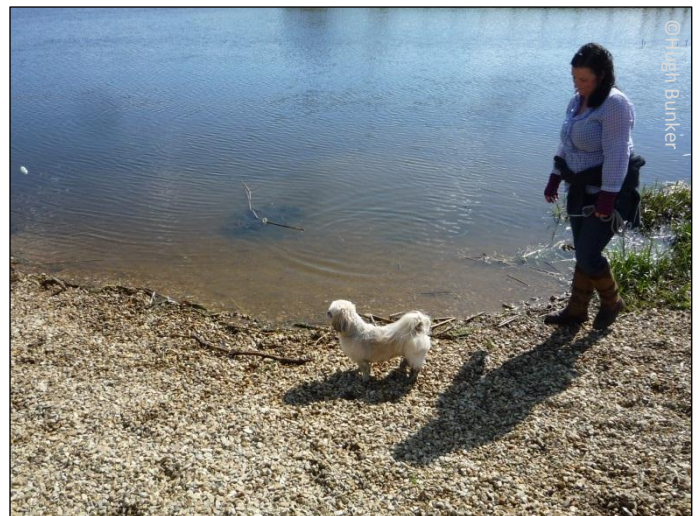
*Fig 14. After: the repaired "dog-dip"*

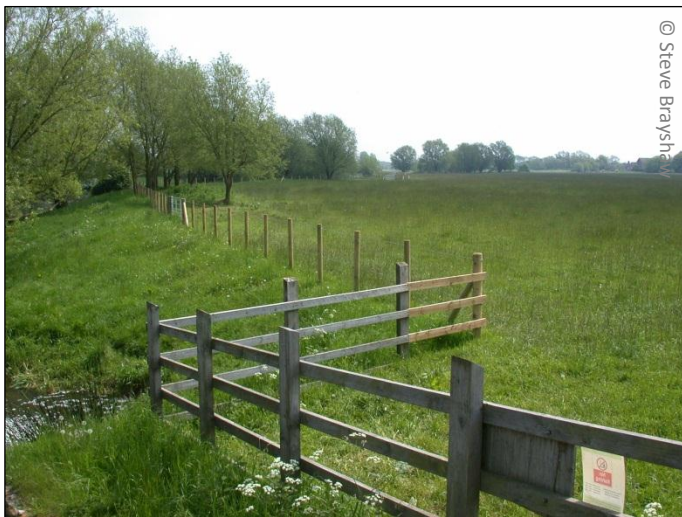
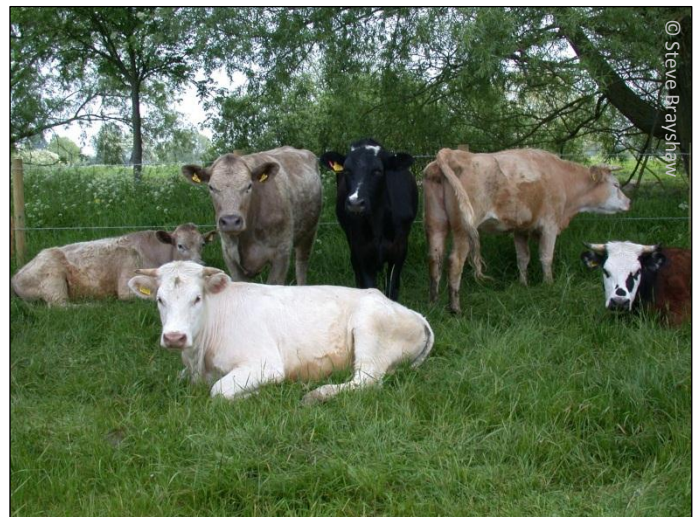
Figs 15 & 16. New Stock fencing protecting in-channel grassland and wet woodland

At the start of the scheme all the redundant fencing around the wet woodland and the damp berm downstream of the bridge was removed. On completion of the in-stream works new fencing (wooden posts and 2 lines of barbed wire) was erected to protect the repaired banks; broad areas of damp riparian grassland that occur within the channel; the wet woodland area; the refuge pools; and a small group of trees at the confluence of the back channel and the main river channel. Simple pipe-stiles were provided along the fence-lines, which were set back from the bank crest, to allow access for anglers. Metal field gates were erected to allow access for stock to the in-channel grassland to enable light, controlled grazing to take place when conditions are suitable thus preventing the development of rank grassland and scrub.

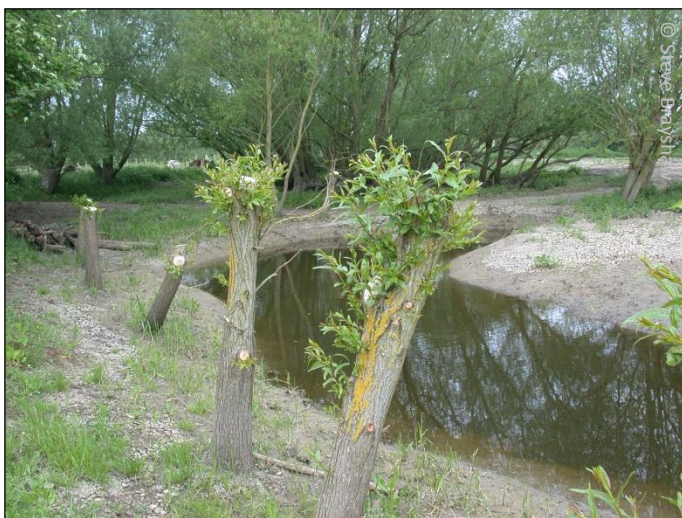
Fig 17. New pollard willows

A limited amount of tree work was undertaken. Several young willow trees were pollarded on the edge of the wet woodland to allow access for machinery to excavate the refuge pool. These will regenerate rapidly to provide shade, which will improve the quality of the refuge. Two live willow limbs were also dropped into the water and secured to narrow the channel and create a bankside fish refuge.

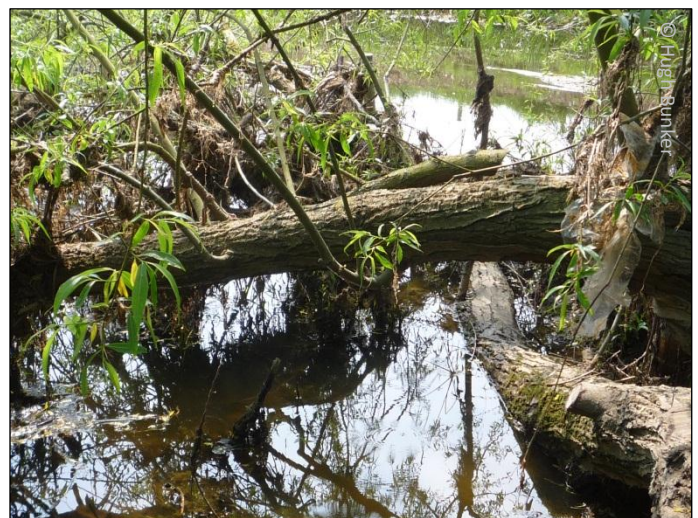
Fig 18. Live willow limbs secured in channel

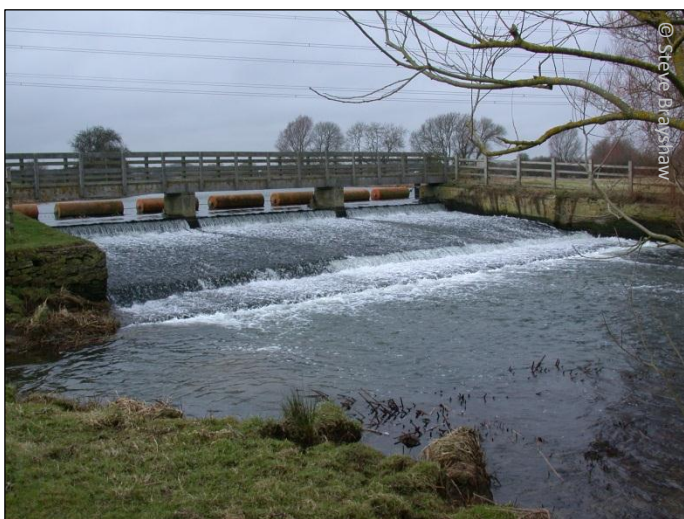
Fig 19. Water Newton Weir is currently a barrier to fish and eel passage

As the works were completed in the spring it was too late to undertake the proposed alder planting on the southern bank to provide additional shade. Tree cribs were constructed and Nene Park Trust will complete the planting in the winter of 2012/13. In addition a fish and eel pass is required at Water Newton Weir.

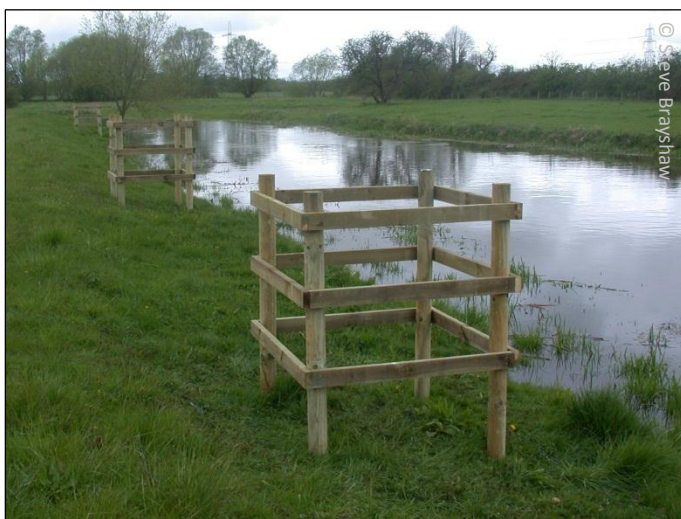
Fig 20. Cribs to protect alder planting in scheduled for winter 2012/13

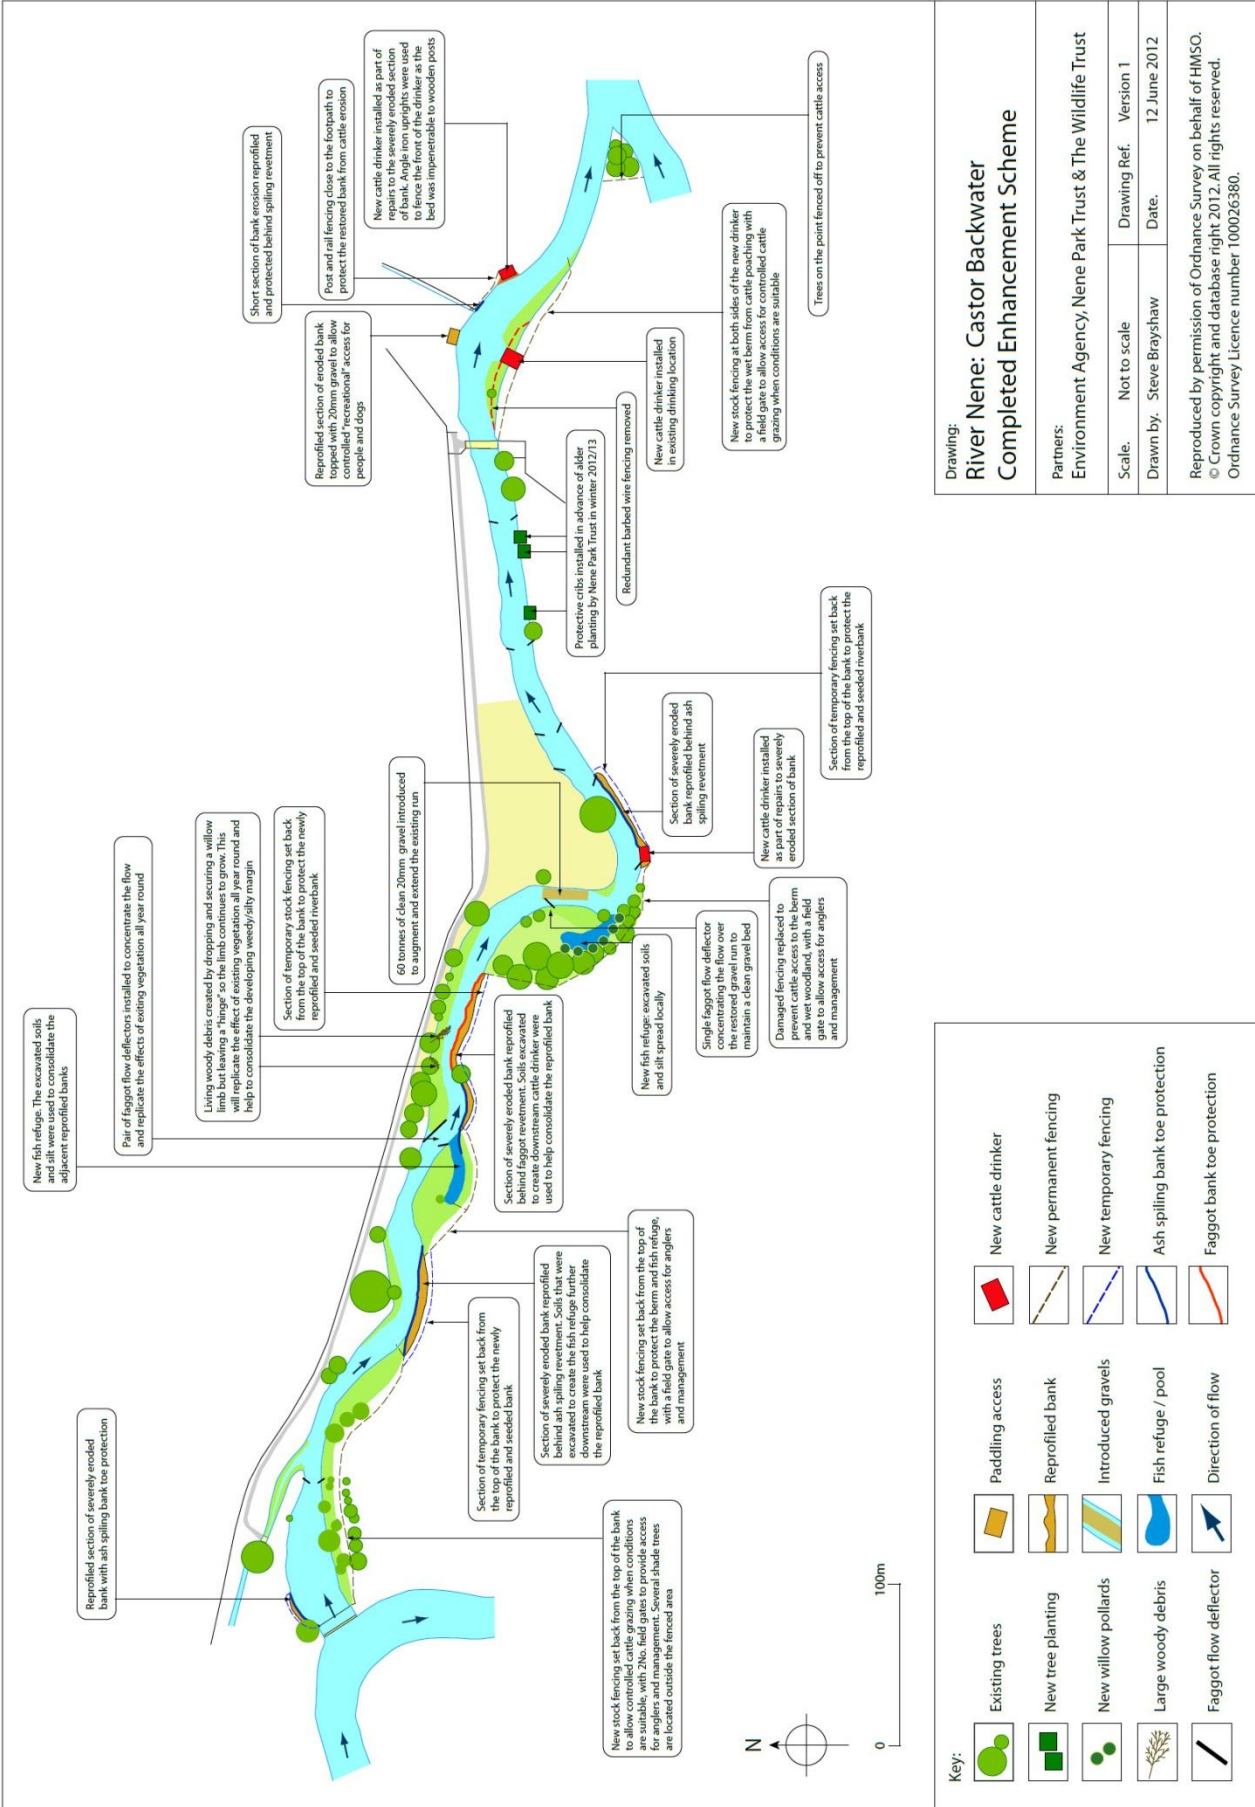
ANNEX 1: The Completed Enhancement Scheme

The main elements of the project were implemented in March 2012. The drawing in Annex 1 shows the locations of all the elements of the completed scheme. The techniques used are described below. It should be noted that the works started during a period of particularly low flows and concluded following a period of heavy spring rainfall which caused the river to overtop its banks.
