We left Arborfield in the last article with a rather sorry looking river which had suffered from too much engineering and not enough maintenance in the past which in turn had led to the loss of some important spawning habitats.

In 2010, some money was committed by Thames Water to put right one of the problems. At that same time, plans were being hatched to carry out a much larger programme of amelioration which would improve the overall habitat for fish and wildlife and allow fish migration upstream. This article details some of the works completed

Part 2: How things
got put right

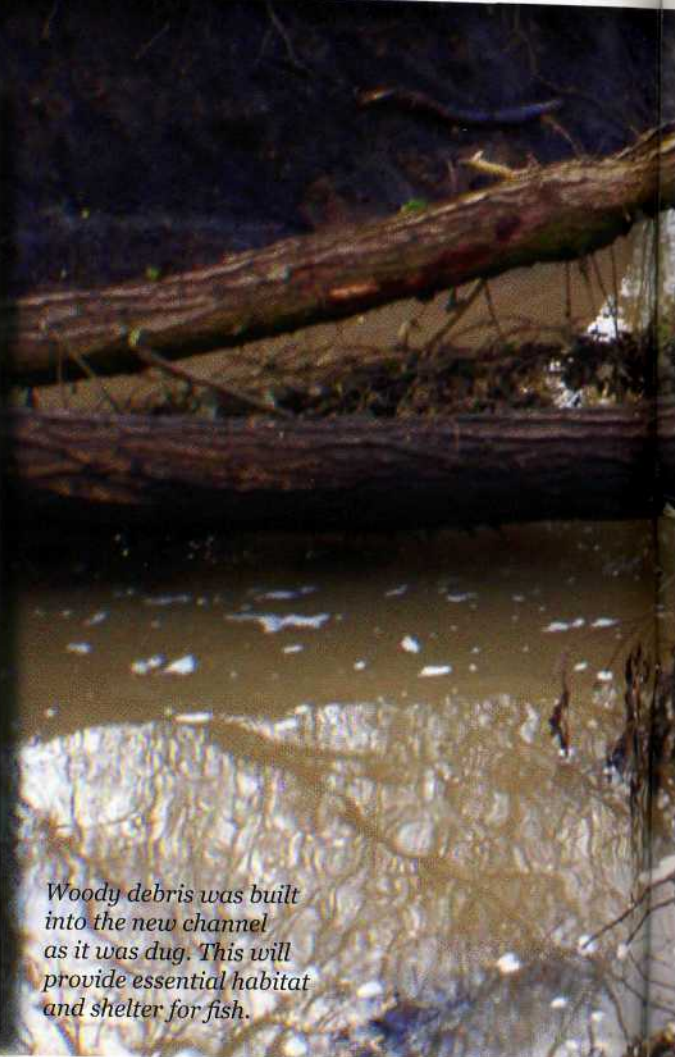
Woody debris was built into the new channel as it was dug. This will provide essential habitat and shelter for fish.

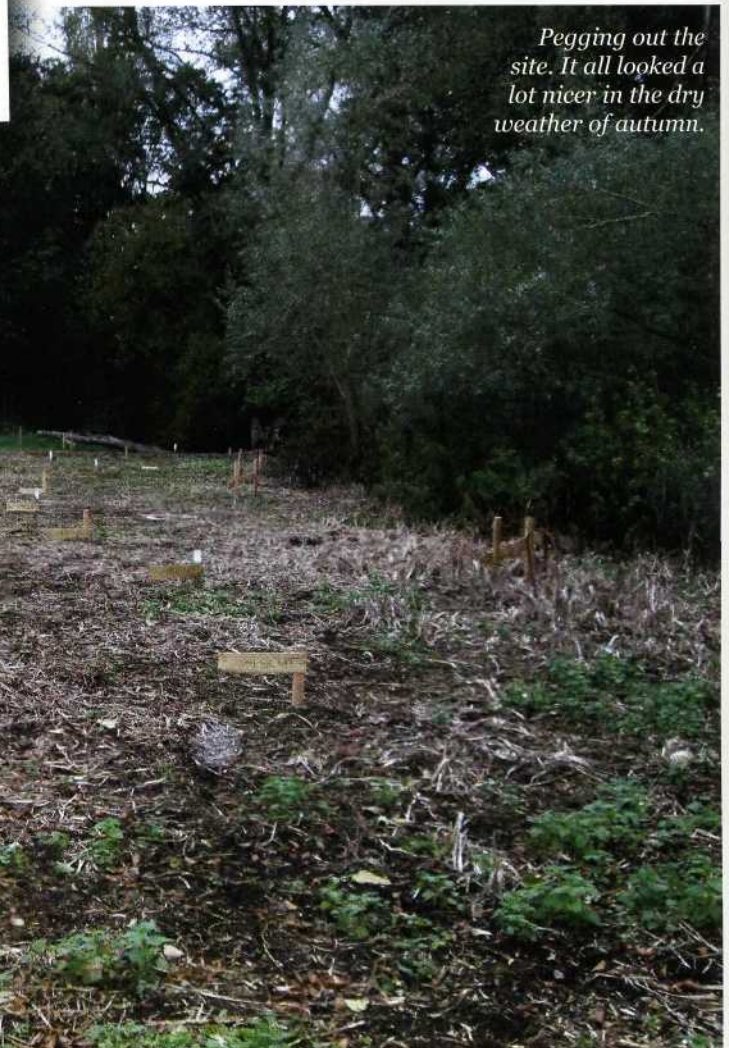
Pegging out the site. It all looked a lot nicer in the dry weather of autumn.

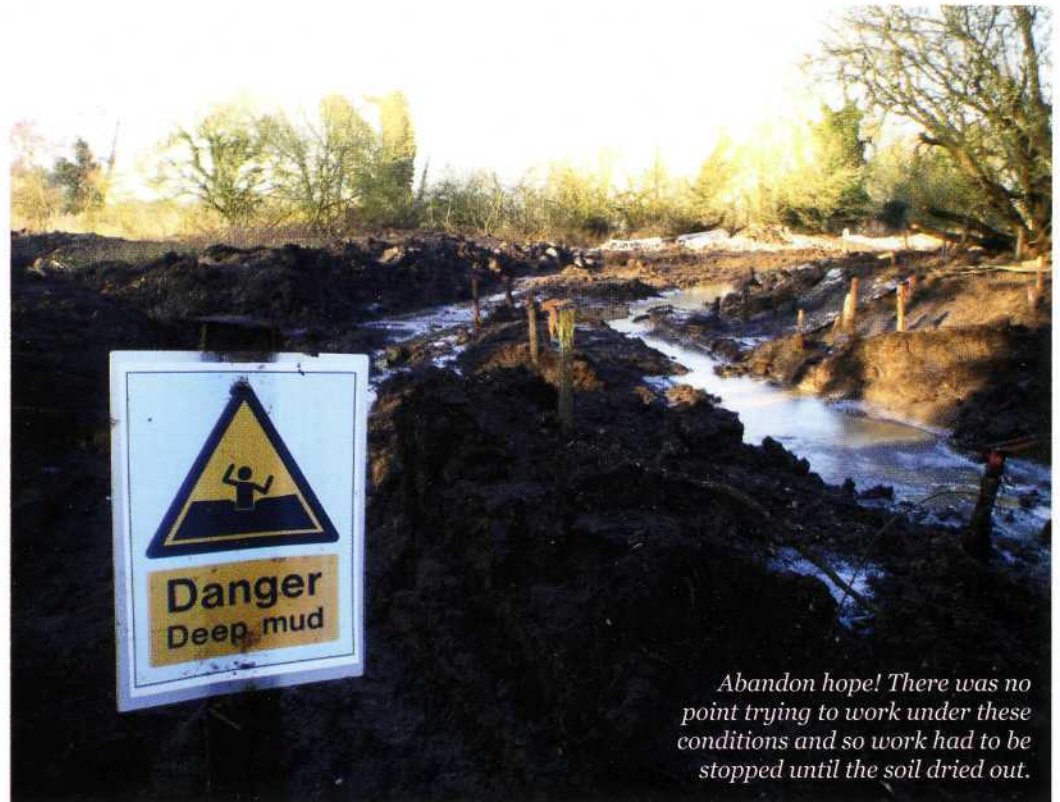
Abandon hope! There was no point trying to work under these conditions and so work had to be stopped until the soil dried out.

Work went well initially but eventually the weather turned and the winter of 2010 bit hard bringing work to a halt in January 2011. The ground became too wet for plant to move around and so works had to be suspended until the ground dried out allowing the accuracy required in the finished product. This was rather frustrating as we had hoped that the spawning gravels would be in place ready for 2011. Quite a lot of progress was made on digging the channel but, as some essential completion works could only be carried out with the channel dry, it was not possible to remove the temporary coffer dam at the top end and allow water through. However, as it took no flow and so erosion was not a risk, the lower end of the channel was flooded and small fish took up residence straightaway so hopefully, that will have served as a refuge for small fry already and done its bit to boost recruitment.
